SIGNIFICANT FINDINGS OVERVIEW

SIGNIFICANT FINDINGS – 2021 INSPECTIONS

- **41-120-105:** This is a 40.5' Single Span Pre-Stressed Precast Concrete Box Beam Bridge (Year constructed is unknown. Estimated to be approximately 1975) on Christensen Road – Immediately West of the intersection with Maitland Road.

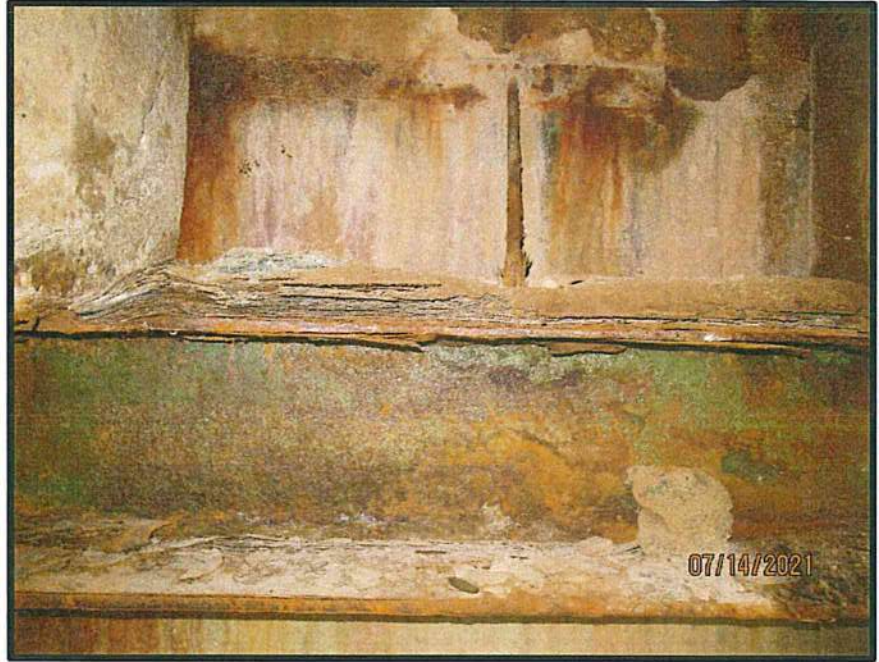
This structure has severe corrosion resulting in significant loss of section of the abutment caps and piling.

Typical Section Loss of Abutment Cap

Due to the amount of repair/replacement required to return this structure to legal load capacity we recommend replacement.

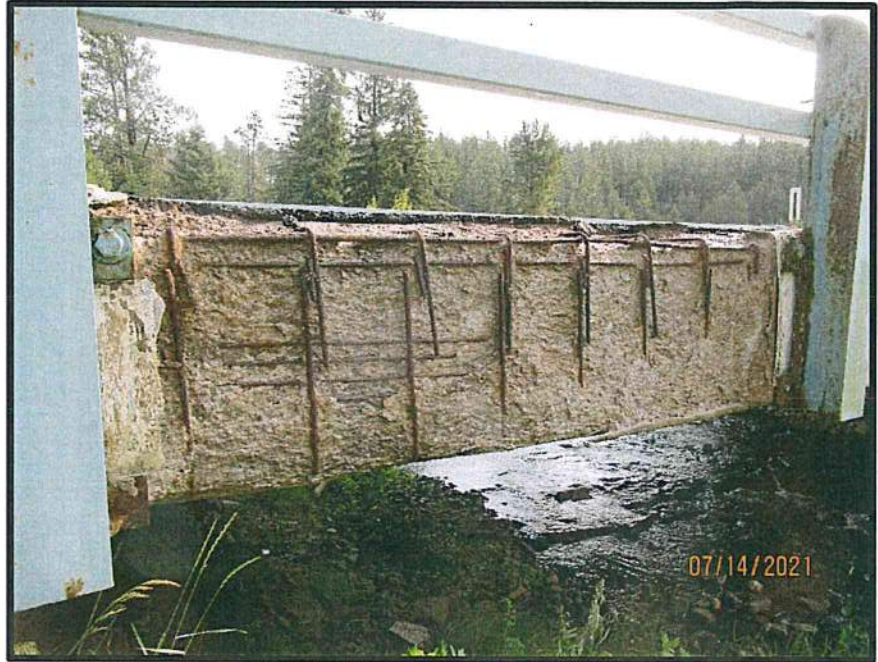
In 2020 a critical finding report was filled out for this structure and was submitted due to a failed fiber wrap repair to the southmost prestressed concrete deck unit. The fiber wrap had fallen off exposing a very large area of soft and weak concrete as well as rebar and prestressing strands. We recommended closure of that portion of the bridge. County had properly signed and coned the damaged beam off from traffic, but the cones had been pushed to the side of the rail. Please monitor cones to assure traffic remains off beam 10.

41-250-268 Severe Deterioration of South Exterior Beam

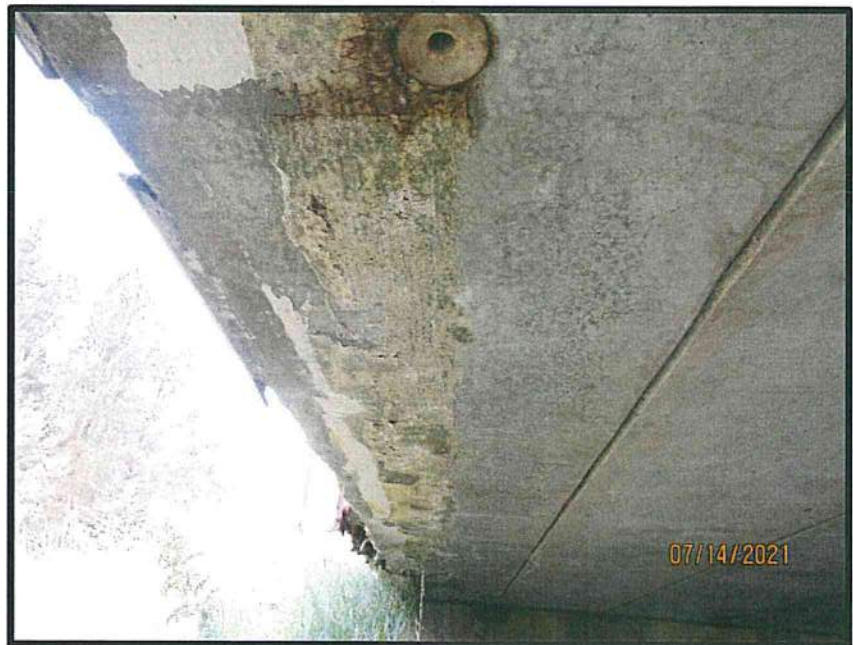
41-249-268 Deterioration of South Exterior Beam
